## Section 504 Self-Evaluation

These assessments constitute updates of the assessments of Millbury parks, playgrounds and conservation areas that were completed by James M. Mazik and incorporated into the November 2006 Town of Millbury Accessibility Plan. Town Planner Laurie Connors and Disabilities Commission Member Michael Kennedy conducted follow up site visits to the facilities on May 30, 2008 and June 13, 2008 to ascertain whether the information within the 2006 Accessibility Plan was still accurate. Changes were made as necessary.

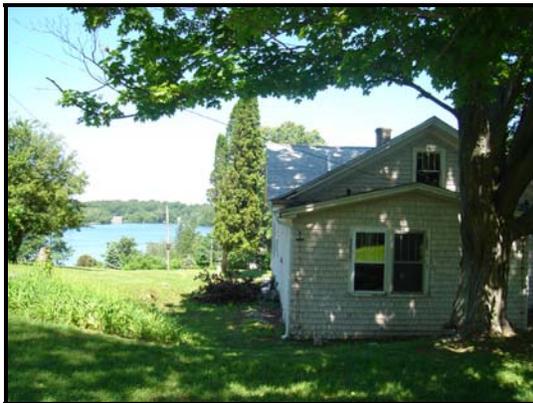
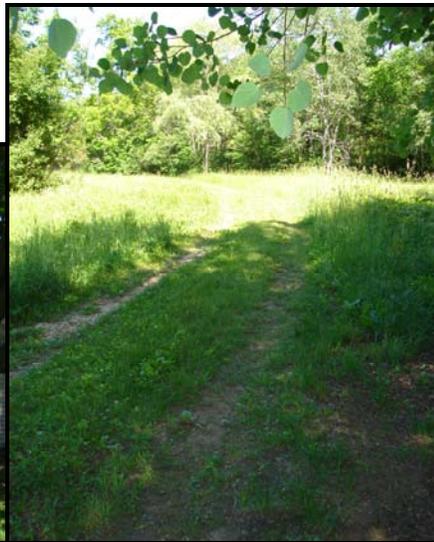
**Butler Farm:** Municipal open space consisting of office space, a community garden, camping sites, trails, and 3 picnic tables. No formal parking exists and no signage or markings provide an on-site accessible space. No accessible routes of travel exist to the house, community garden, camping sites, and trails.

General Description of Obstacle Which Limits Mobility or Access	Type of Action to be Taken	Priority	Feasibility
1. No designated accessible parking space, line striping or signage.	Designate off-street accessible space. Provide related striping and accessible signage.	Highest priority.	Can be undertaken by DPW.
2. No accessible route of travel exists to the office space, community garden, camping sites, trails and picnic tables.	Construct a 48" wide w/36" clear width accessible pathway to all facilities.	Highest priority.	Minor modification which requires skilled or specialized work.
3. No accessible picnic tables.	Install one picnic table which provides a clear space under the table top not less than 30" wide and 19" deep and not less than 27" clearance from the ground to the underside of the table.	Highest priority.	Can be undertaken by DPW.

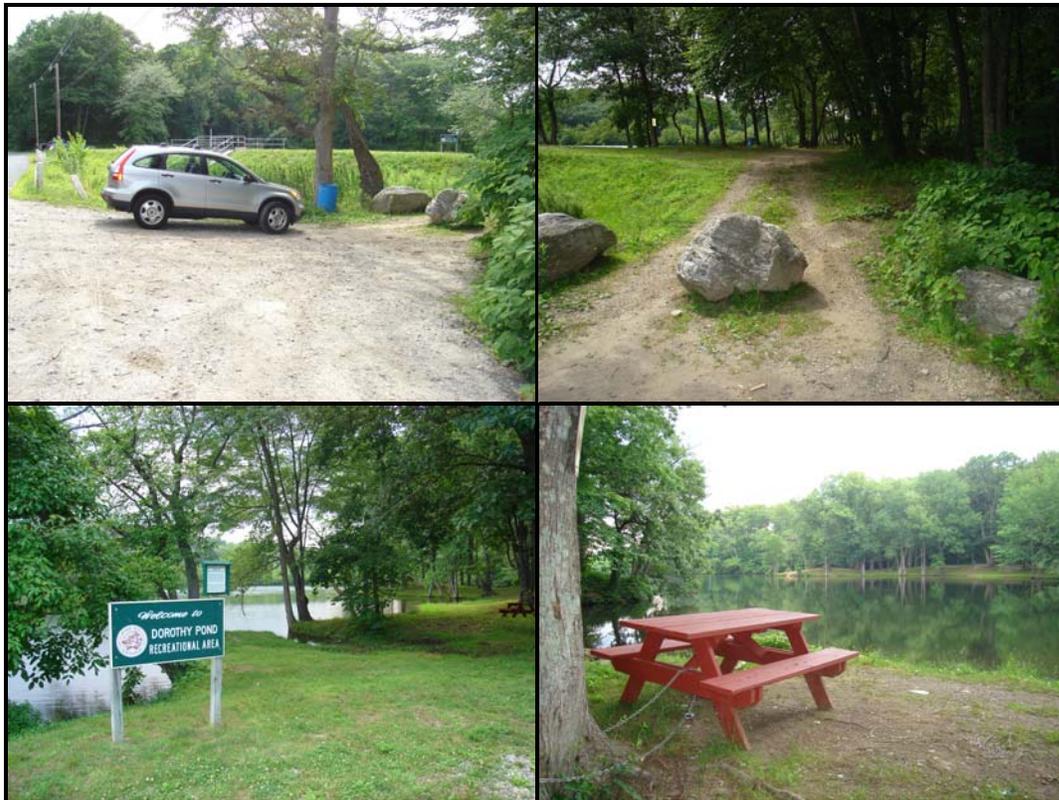
**Dorothy Pond Recreational Area:** Municipal open space consisting of picnic tables, the Dorothy Pond dam, a trail and informal fishing areas. Two informal parking areas provide parking for a maximum of four cars. No signage or markings provide an on-site accessible space. No accessible routes of travel exist to the picnic table, trail and informal fishing areas.

General Description of Obstacle Which Limits Mobility or Access	Type of Action to be Taken	Priority	Feasibility
1. No on- or off-street designated accessible parking space, line striping or signage.	Designate on- or off-street accessible space. Provide related striping and accessible signage.	Highest priority.	Can be undertaken by DPW.
2. No accessible route of travel exists to the picnic tables, informal fishing areas, or trail.	Construct a 48" wide w/36" clear width accessible pathway to a picnic table, informal fishing area, and trail.	Highest priority.	Minor modification which requires skilled or specialized work.
3. No accessible picnic tables.	Provide one picnic table which provides a clear space under the table top not less than 30" wide and 19" deep and not less than 27" clearance from the ground to the underside of the table.	Highest priority.	Can be undertaken by DPW.

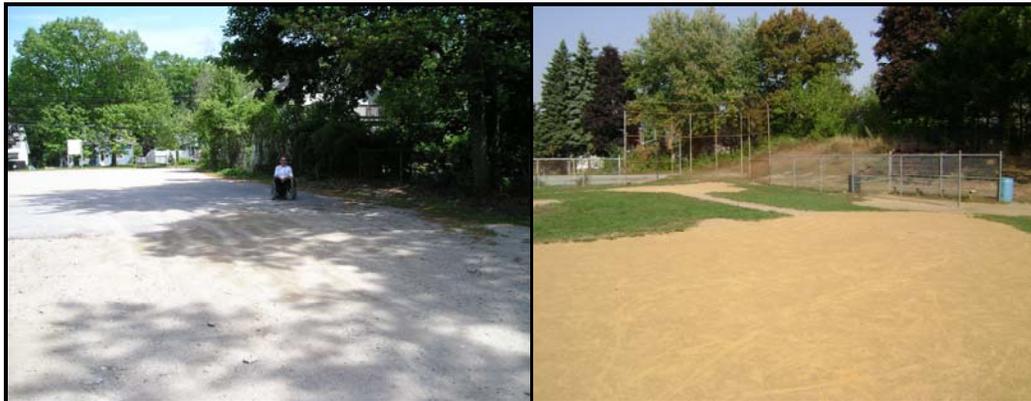
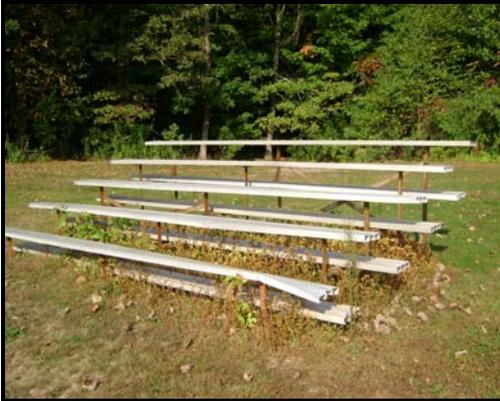
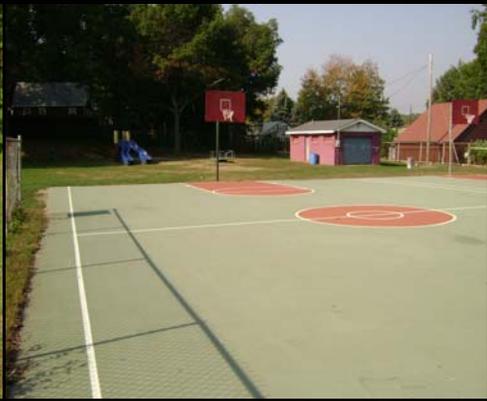
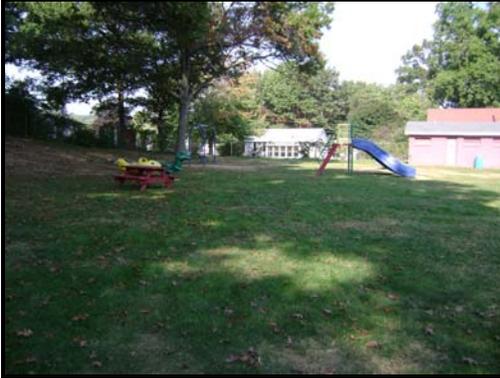
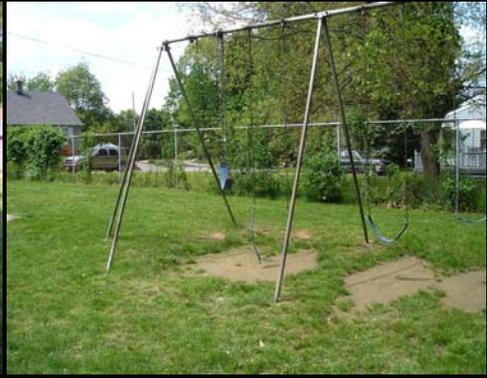
**East Millbury Park:** Neighborhood playground and park consisting of 2 baseball fields, 2 basketball courts (3 new nylon nets needed), 8 swings (3 swings need repair/replacement), slides, a carousel, 2 spring rider play components, and 2 picnic tables. The parking area is partially improved, with the parking closest to the entrance being an unimproved and unstable surface. An accessible portable toilet is located on the unimproved parking lot next to the main entrance. No accessible routes of travel exist to the ball fields, basketball courts or play components. None of the 3 bleachers have railings. Future playground equipment replacement or expansion should comply with the guidance provided in the Town of Millbury Accessibility Plan.

General Description of Obstacle Which Limits Mobility or Access	Type of Action to be Taken	Priority	Feasibility
1. No designated accessible parking space, line striping or signage.	Surface an approximately 600 s.f. area to create firm and level parking area next to main entry. Designate one 8' wide accessible passenger vehicle parking space and one 8' wide van accessible parking space, separated by 8' wide accessible access aisle. Provide related striping and accessible signage.	Highest priority.	Can be undertaken by DPW.

2. No accessible route of travel to ball fields, basketball court and play components.	Construct a 48" wide w/36" clear width accessible pathway to all ball fields, play components and the basketball court.	Highest priority.	Minor modification which requires skilled or specialized work.

3. Lack of railings on bleachers.	Install accessible compliant railings.	Highest priority.	Minor modification which requires skilled or specialized work.

4. No accessible swings exist in the play area.	Based on number of swings, add one accessible swing seat.	Highest priority.	Can be undertaken by DPW.
5. No accessible picnic tables.	Provide at least one picnic table which provides a clear space under the table top not less that 30" wide and 19" deep and not less than 27" clearance from the ground to the underside of the table.	Highest priority.	Can be undertaken by DPW.

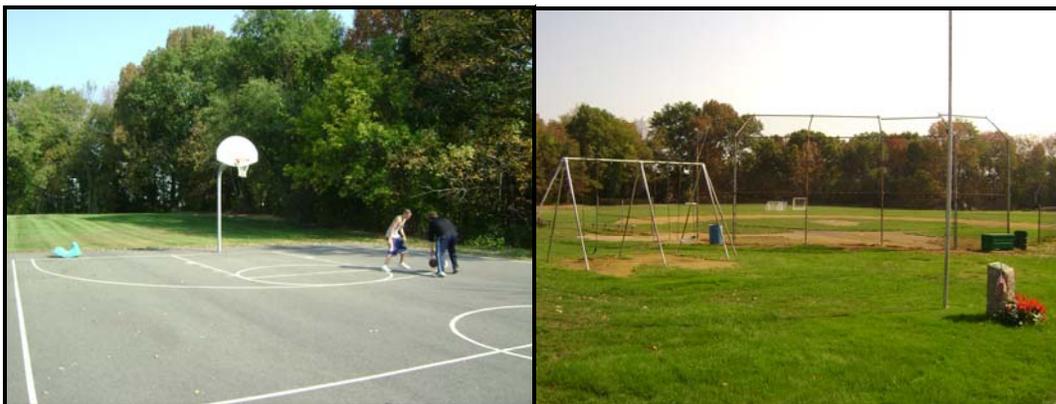
**Greenwood Street Park:** Neighborhood playground and park consisting of a baseball field, a soccer field, a basketball court (2 new nylon nets needed), 4 swings (1 swing needs repair/replacement), 2 spring rider play devices, and 2 picnic tables. No designated accessible parking exists in the “upper” parking lot. The “lower” lot has two non-compliant striped accessible spaces. An accessible portable toilet is located in the “upper” parking lot. Installation of a new accessible sidewalk on Greenwood Street provides the only accessible route from the “upper” to “lower” parking lots. No accessible routes of travel exist to the ball fields, play components or basketball court from either parking lot. None of the bleachers have railings. Future playground equipment replacement or expansion should comply with the guidance provided in the [Town of Millbury Accessibility Plan](#).

General Description of Obstacle Which Limits Mobility or Access	Type of Action to be Taken	Priority	Feasibility
1. No designated accessible parking space, line striping or signage in the upper parking lot and non-compliant parking due to lack of signage and sufficient access aisle width in lower parking lot.	In both upper and lower parking lots, designate one 8’ wide accessible passenger vehicle parking space and one 8’ wide van accessible parking space, separated by an 8’ wide accessible access aisle. Provide related striping and accessible signage.	Highest priority.	Can be undertaken by DPW.

2. No accessible route of travel exists to the ball fields, play components and basketball court.	Construct a 48” wide w/36” clear width accessible pathway to both ball fields, play components and the basketball court.	Highest priority.	Minor modification which requires skilled or specialized work.

3. Lack of railings on bleachers.	Install accessible compliant railings.	Highest priority.	Minor modification which requires skilled or specialized work.

4. No accessible picnic tables.	Provide at least one picnic table which provides a clear space under the table top not less than 30" wide and 19" deep and not less than 27" clearance from the ground to the underside of the table.	Highest priority.	Can be undertaken by DPW.

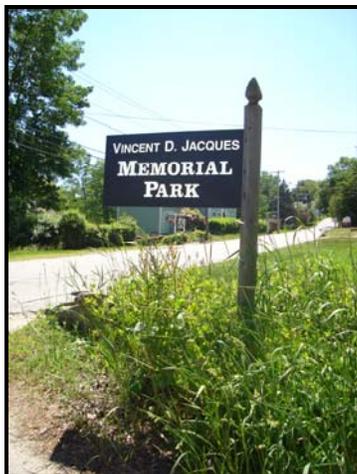
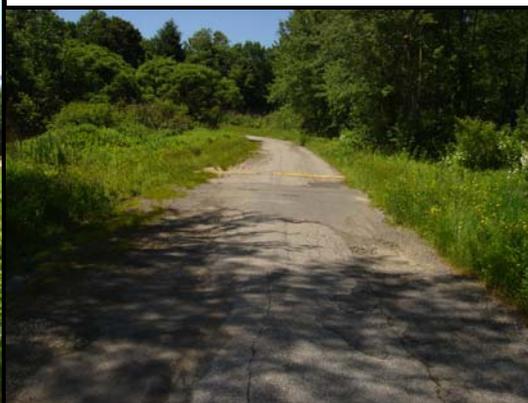
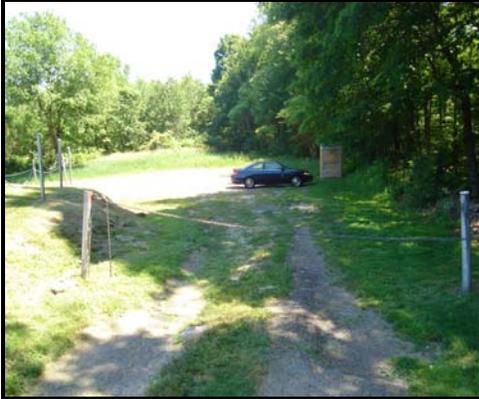
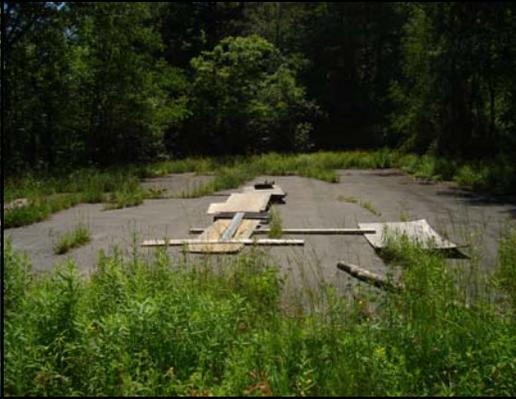
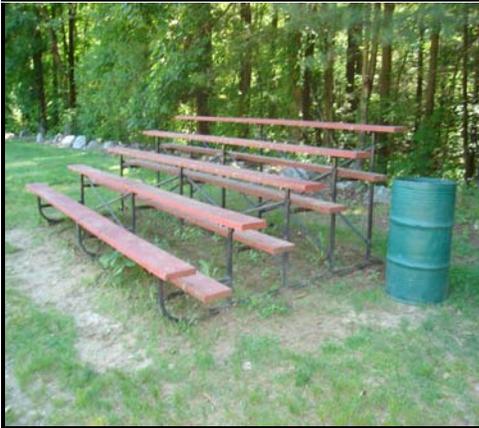
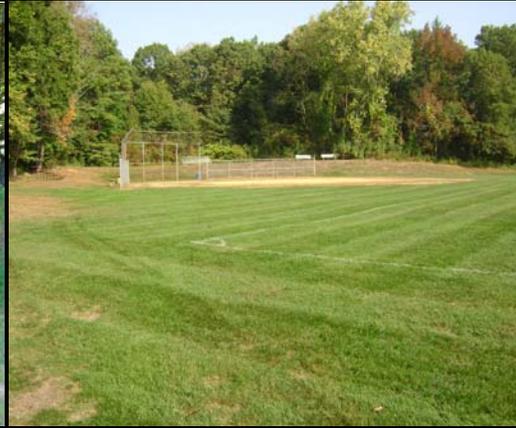
**Jacques Park:** A rural “neighborhood” park with minimal improvements and in an overall “poor” condition. The park consists of an overgrown and inaccessible basketball court, a baseball field, 2 bleachers and an accessible portable toilet. The basketball court appears to be abandoned due to the extensive overgrowth and condition of the court. There is evidence that youth are using the court for skateboarding. No formal parking exists adjacent to the basketball court. Should the basketball court be put back into use, it will need to be made compliant by creating an accessible route of travel to this facility. The parking for the baseball field is an unimproved and unstable gravel surface and therefore non-compliant. No signage or striping is provided. The “accessible” portable toilet is located on an unimproved and uneven gravel and grassed surface rendering it non-accessible. No accessible route of travel exists to the ball field or bleachers, in fact a chain inhibits access via wheelchair. Railings are not provided on the bleachers.

General Description of Obstacle Which Limits Mobility or Access	Type of Action to be Taken	Priority	Feasibility
1. No designated accessible parking space, line striping or signage.	Surface an approximately 600 s.f. area to create a firm and level parking area next to the main entry. Designate one 8' wide accessible passenger vehicle parking space and one 8' wide van accessible parking space, separated by an 8' wide accessible access aisle. Provide related striping and accessible signage.	Highest priority.	Can be undertaken by DPW.

2. No accessible route of travel exists to the ball field and "accessible" portable toilet.	Construct a 48" wide w/36" clear width accessible pathway to the baseball field and the designated location of the portable toilet.	Highest priority.	Minor modification which requires skilled or specialized work.

3. Lack of railings on bleachers	Install accessible compliant railings.	Highest priority.	Minor modification which requires skilled or specialized work.

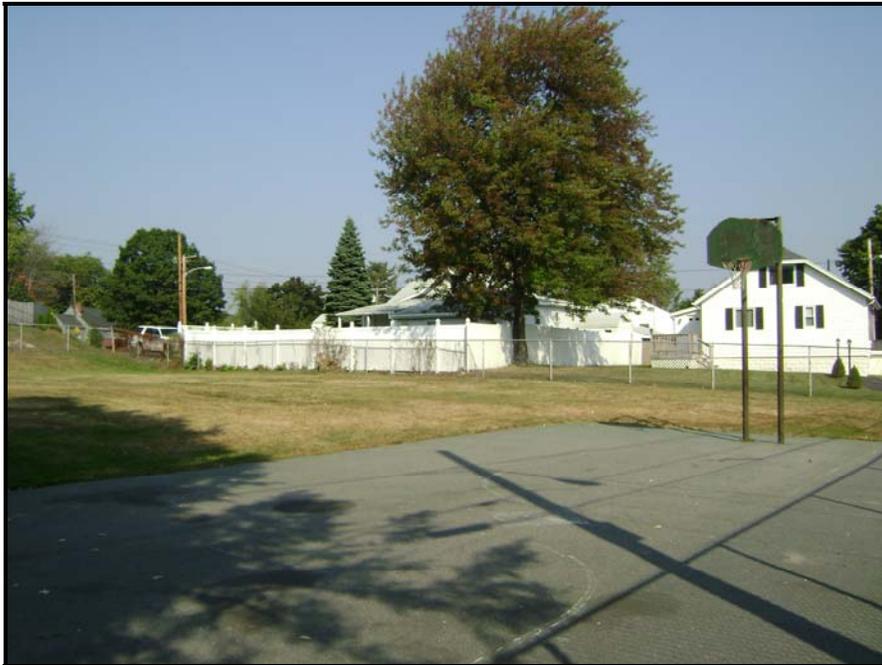
**James Dorenzo Park (a.k.a Dorothy Pond Tot Lot):** Neighborhood park consisting of a basketball court and open field. No on-site parking exists and no signage or markings provide an on-site accessible space. Future playground equipment replacement, if it should occur, should comply with the guidance provided in the Town of Millbury Accessibility Plan.

General Description of Obstacle Which Limits Mobility or Access	Type of Action to be Taken	Priority	Feasibility
5. No on-street designated accessible parking space, line striping or signage.	Designate on- street accessible space. Provide related striping and accessible signage.	Highest priority.	Can be undertaken by DPW.
6. No accessible route of travel exists to the basketball court.	Construct a 48" wide w/36" clear width accessible pathway to the basketball court.	Highest priority.	Minor modification which requires skilled or specialized work.

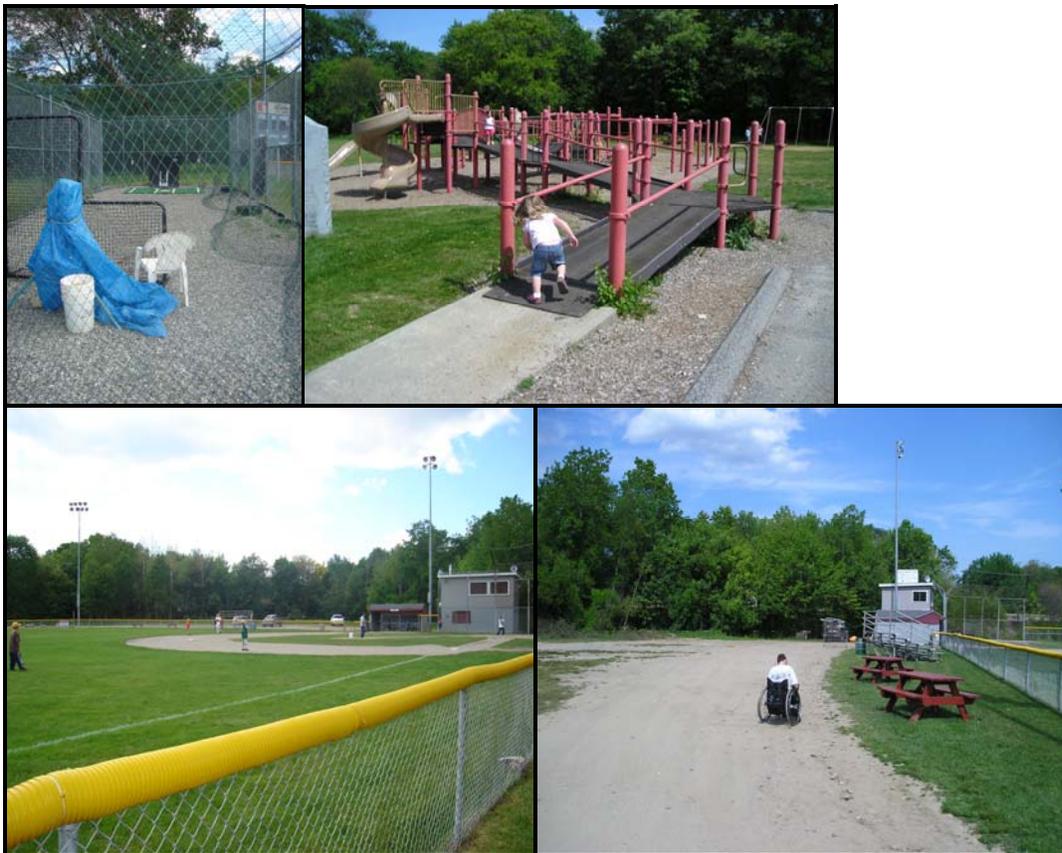
**Washington Street Park:** Town-wide recreational complex consisting of a baseball field, batting cage, 2 basketball courts, play area (Woolie World), 6 swings, 2 spring rider play components, 2 bleachers, 8 non-accessible picnic tables, and a pavilion containing a concession stand and bathrooms. An accessible portable toilet is located in the parking lot, which is located a significant distance from the pavilion. No designated accessible parking spaces are provided. No accessible routes of travel exist to the baseball field, basketball court, pavilion inclusive of concession stand and bathrooms, batting cage, and various play components. Although “Woolie World” does appear to have accessible play components and is minimally accessible from the parking lot – an accessible route around and within the play area does not exist. Future equipment replacement or expansion, if it should occur, should comply with the guidance provided in the Town of Millbury Accessibility Plan. None of the swing sets contain an accessible swing. The bleachers have the required railings. None of the picnic tables provide the required knee clearance and clear width space. The counter at the concession stand is 41 ½” a.f.f. which exceeds the maximum height limit. The facility also contains 2 wholly non-compliant and inaccessible bathrooms.

General Description of Obstacle Which Limits Mobility or Access	Type of Action to be Taken	Priority	Feasibility
1. No designated accessible parking space, line striping or signage.	Designate one 8' wide accessible passenger vehicle parking space and one 8' wide van accessible parking space, separated by 8' wide accessible aisle. Provide related striping and accessible signage.	Highest priority.	Can be undertaken by DPW.

2. No accessible route of travel exists to the ball fields, basketball courts, play equipment and related facilities.	Construct a 48" wide w/36" clear width accessible pathway to all playing fields and facilities. Direct access into the basketball courts from the parking lot can easily be obtained by removing a portion of asphalt curbing and providing striping.	Highest priority.	Minor modifications which require skilled or specialized work.

3. No accessible route of travel exists to, within or around Woolie World.	Construct a 48" wide w/36" clear width accessible pathway to and around the play area. Install a stable, firm and slip-resistant as well as "impact attenuating" surface around and to play equipment. Acceptable materials include interlocking rubber matting, plastic matting, poured in place rubber surfacing and specially bonded wood fibers.	Highest priority.	Minor modifications which require skilled or specialized work.

4. Public bathrooms in pavilion are wholly non-compliant including door hardware, signage, dispensers and all toilet features. A 7" abrupt change in level surface exits to access both the men's and women's bathrooms.	Construct fully compliant men's and women's accessible bathrooms with either a ramped or on-grade level approach.	Priority.	Major modifications which require skilled or specialized work.

5.	The counter height at the concession stand is constructed at 41 1/2" a.f.f. which exceeds maximum height requirements by over 7".	Construct a counter below the dispatch window with a maximum height of 34" with a minimum of 27" knee clearance.	High priority.	Minor modifications which require skilled or specialized work.
6.	No accessible swing sets exist in the play area.	Based on number of swings existing, add one accessible swing seat.	Highest priority.	Can be undertaken by DPW.
7.	The picnic tables do not provide the required knee and clear width space.	Provide at least one picnic table which provides a clear space under the table top not less than 30" wide and 19" deep and not less than 27" clearance from the ground to the underside of the table.	Highest priority.	Can be undertaken by DPW.
