City/State: Millbury, MA
Engineer: J.M. Grenier Associates
Sub-Contractor:
Project: Abbott Place (No. 179410990)

Site Inspection Report

Date: Friday, November 20, 2020
Weather: 30s°, Sunny

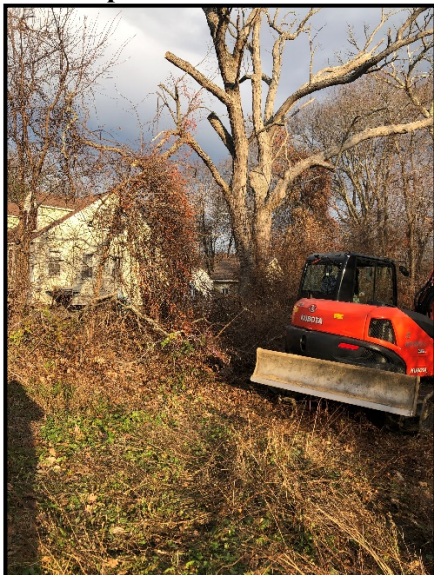
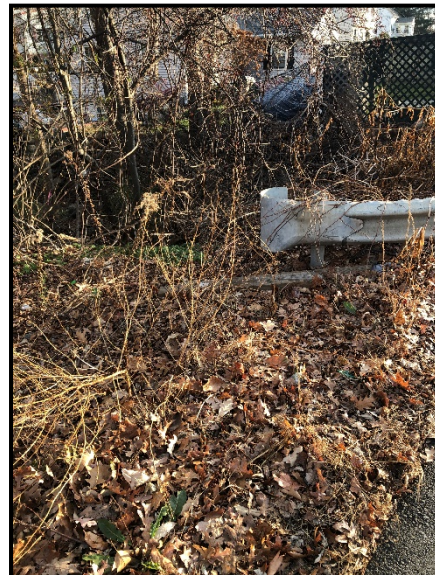
2. Site photos:

- The site is along Rt. 122 in what is suspected to be a MassDOT owned portion. Applicant to confirm during submission.
- Existing MassDOT Curb inlet and existing HMA berm with 5FT wide HMA sidewalk along Rt. 122.
- Appears to be a drainage outfall and conveyance ditch on the eastern side of the site.
- Existing guardrail terminated prior to site entrance.
- Site is very wooded and would require land clearing and tree removal.
- Appears to be both sewer and drainage along Rt. 122

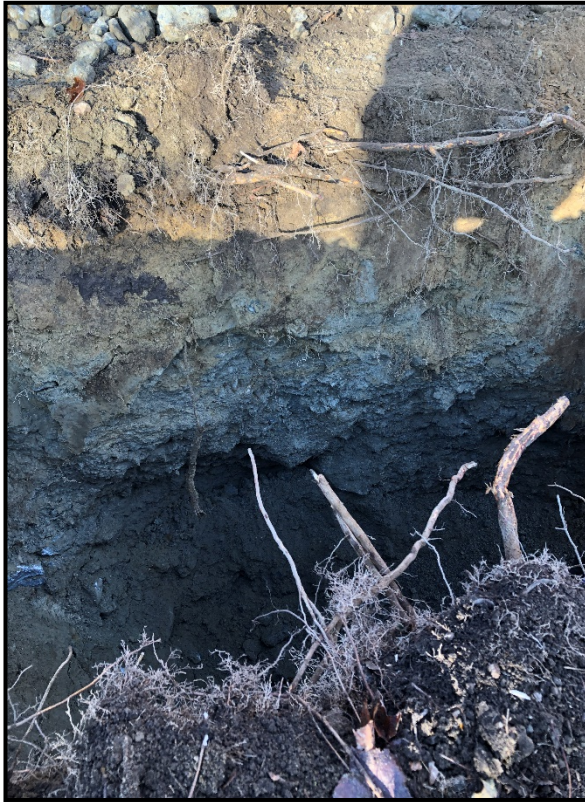
3. Test Pit #1.:

3FT X 10FT 8FT DEEP	
Depth(FT)	Description
Ground	
0"	0" to 6" Ap – leaf and organic matter. Existing woodland 10YR 3/2
6"	6" to 24" Bw – Sandy loam 7.5YR 4/4
24"	
60" ▼	24" to Bottom C – Sandy loam with pockets of cobbles 5Y 7/1 GW – redox features found at 60" 5Y6/8
Bottom 96"

Groundwater was estimated to be at 60" below ground. Slight redox features were observed. This was consistent for elevation with the existing down gradient drainage ditch. The down gradient drainage ditch had water flowing during the time of the test pit.
