Re: Wetland Inspection along Railroad Bed
15 Rice Road Millbury

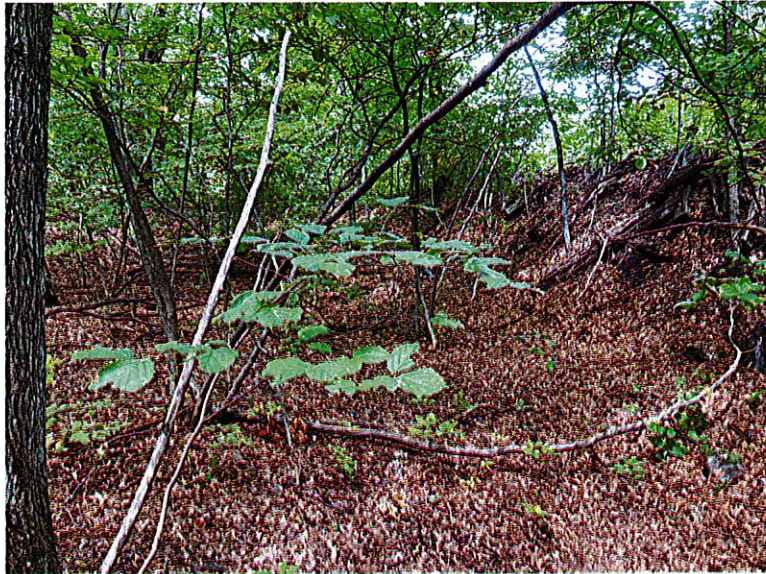
Photo 1. Upland species of Red Oak, witch hazel, American hazel nut and aralia. No staining or other hydrology observed within the area.

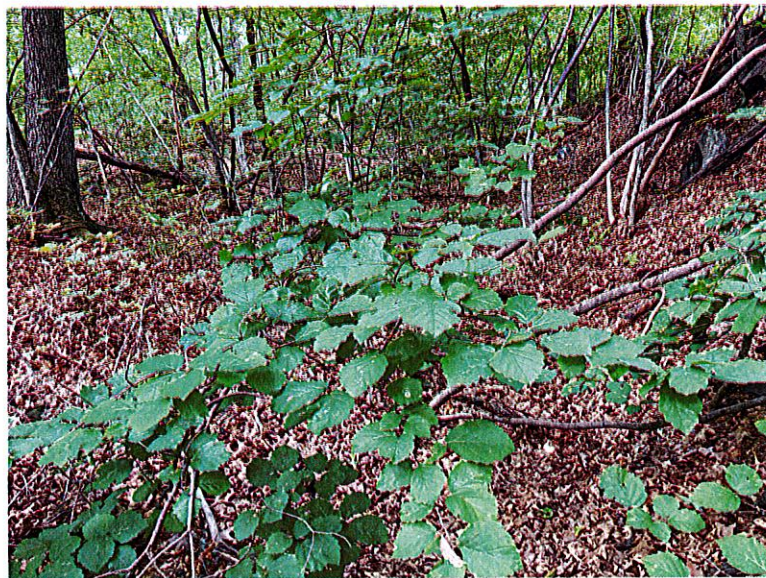
Photo 2. Same upland species observed in a different location along railroad bed.

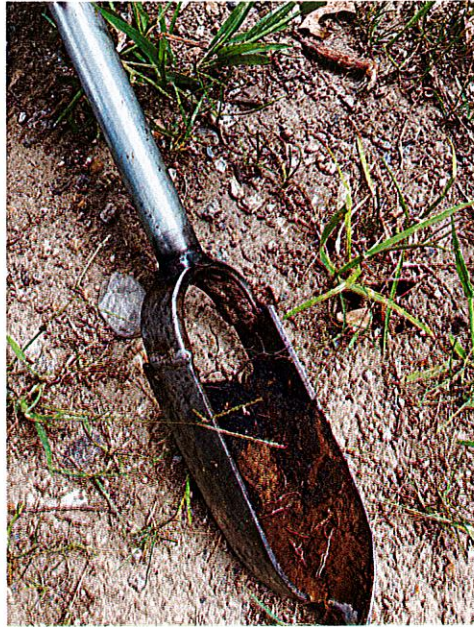
Soil samples were also taken throughout the area. The samples showed a 6-inch layer of 10YR2/2 loam over 14 inches of a 10YR4/4 loamy sand (which is a bright upland soil). In addition, no indicators of hydrology were present. No leaf staining was observed (which would indicate standing water), no puddling of water was observed, and no evidence of flow (stream or moved leaves) was observed in this area (refer to photograph 1 and 2 (no staining) and photograph 3 (soil profile)). As a result, the second requirement of the presence of wetland soils and/or wetland hydrology are not present in this area.

Photo 3. Upland soil profile observed. No gray soils or high chroma mottles observed
